# A Study of the Effects of Carbon Fibers on Home Appliances

Center for Consumer Product Technology  
National Engineering Laboratory  
National Bureau of Standards  
Washington, D.C. 20234

Issued February 1980

NBSIR 79-1952 (NASA)

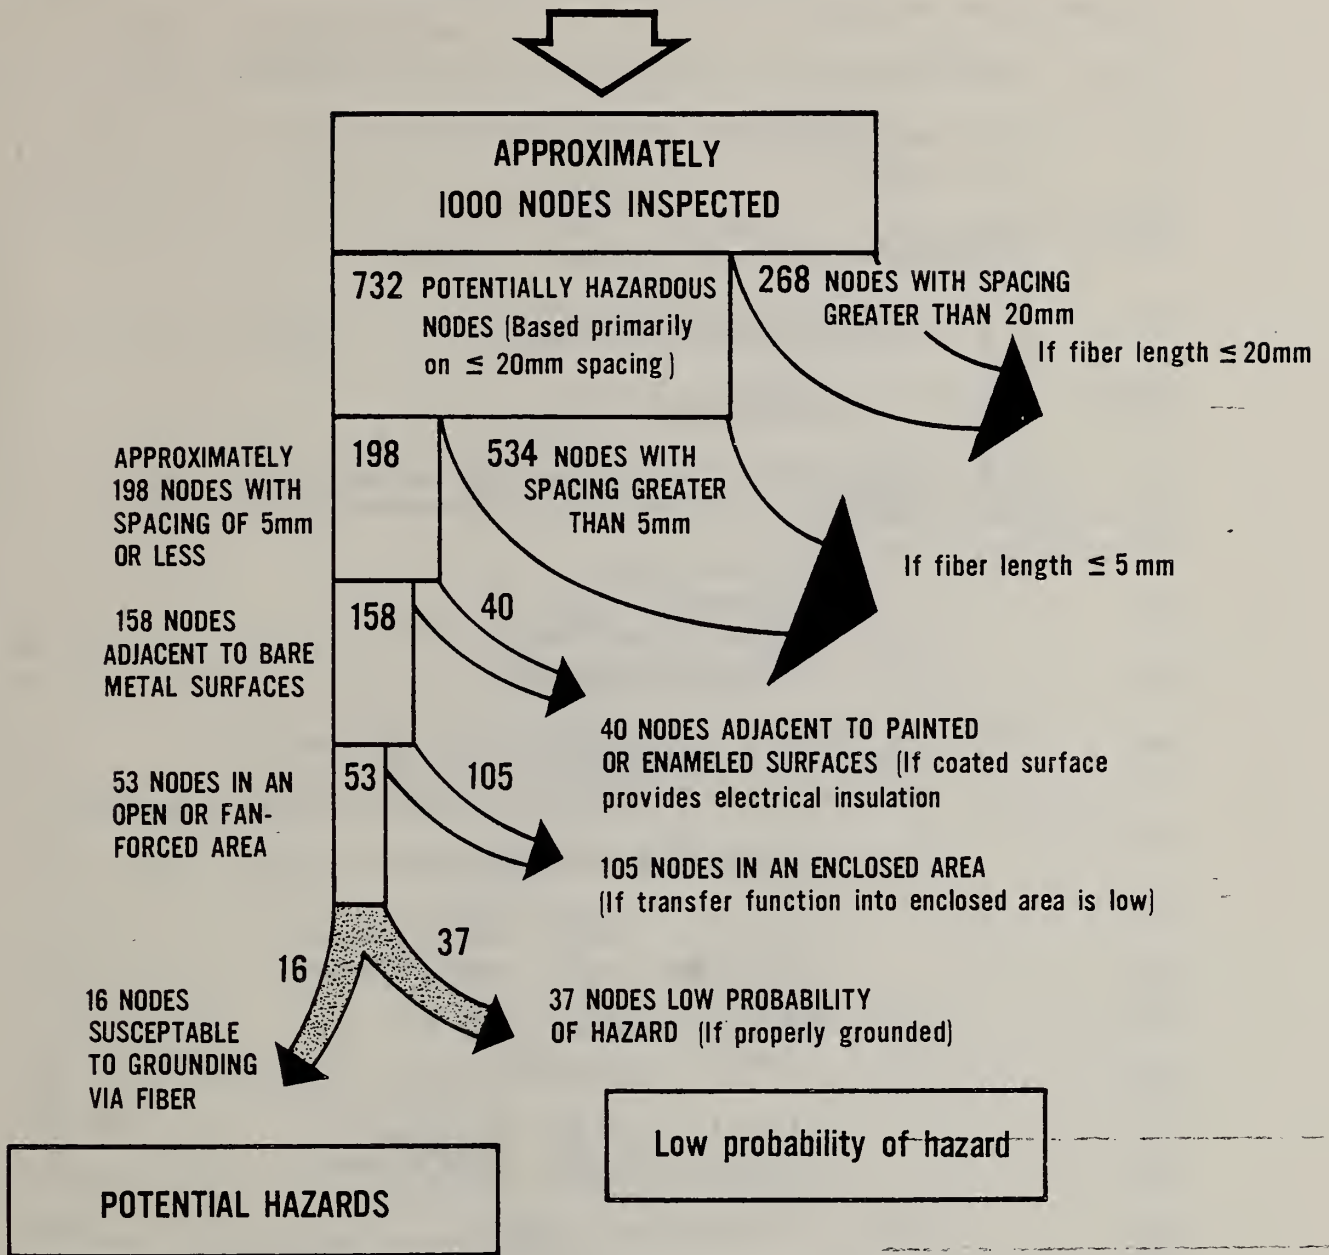
Figure i. Diagram of potential shock hazards.

Forty-seven of the 59 appliances were amenable to evaluation by probe testing and analysis. A diagrammatic view of the evaluation is shown in Figure (i). These 47 appliances collectively contained 732 potential hazards. However, because of constraints such as fiber length, node spacing to the nearest conductive surfaces, surface finish and protective environmental enclosures, only 53 of these

nodes pose significant risk of shock hazard. These 53 potential hazardous nodes must be tempered by the type of power connection. Of the 53 hazardous nodes, 37 represent a hazard only if the power supply ground systems are violated. The remaining 16 hazardous nodes were found in nine small appliance models having no provision for grounding. Whether these 16 hazardous nodes would result in electrical shock to users would depend on a fiber shorting the node to the case and the user touching the case and simultaneously touching a grounded conductor with another part of the body. The probability of these conditions was not evaluated in this study.

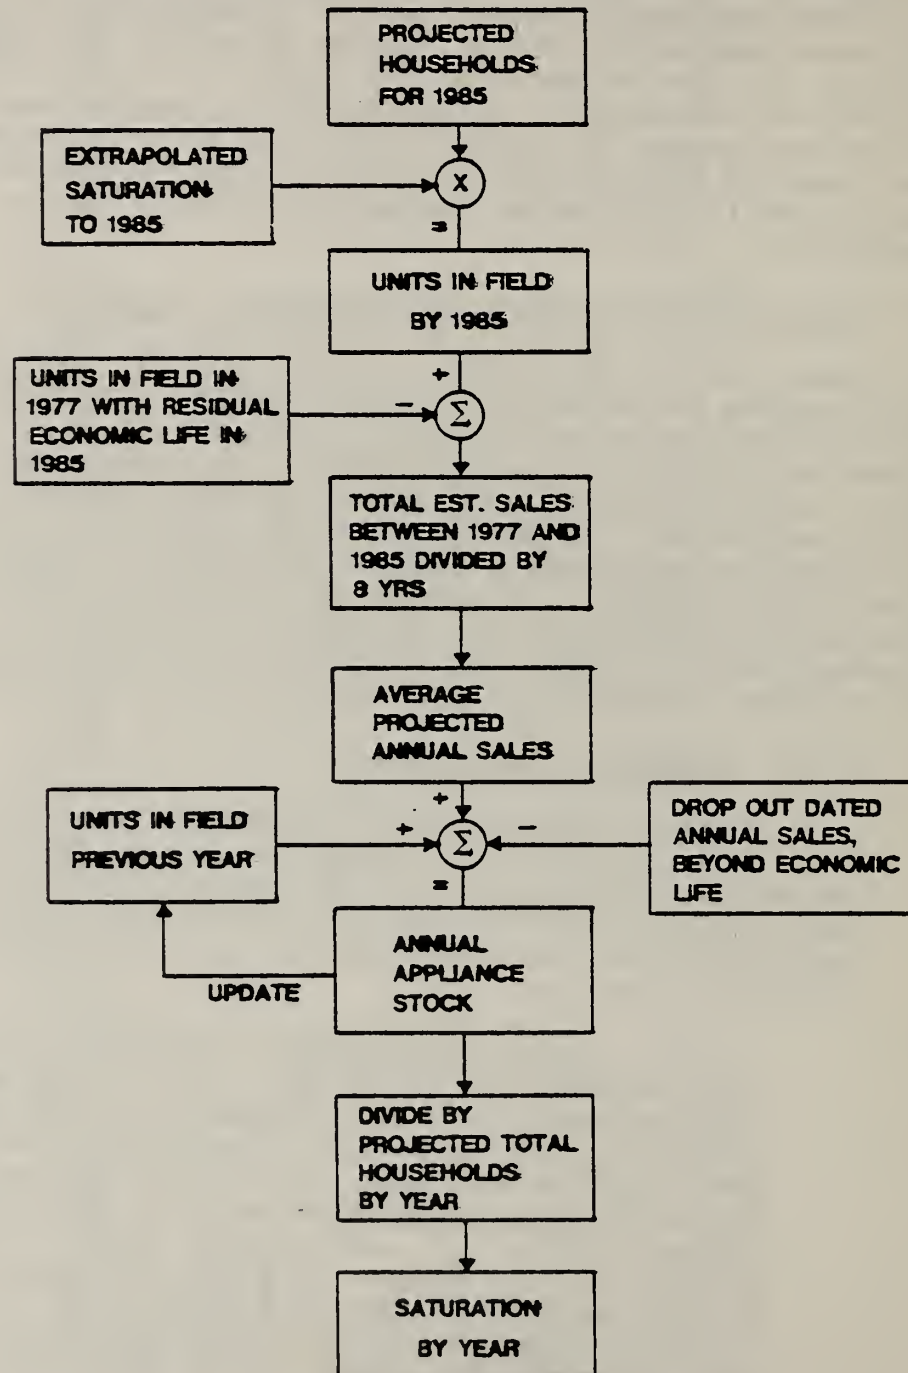
**Figure 3.3**

3.4.1.1 Major Appliances: Figure 3.3 shows a flow diagram of the method used to estimate saturation by year for ranges, clothes dryers, freezers, and disposals. The basic data that were used to estimate the annual saturation were the projected households and the extrapolated values of the 1975 saturation levels. The product of the number of projected 1985 households and the extrapolated, 1985 saturation is the estimated number of units that will be in the field by 1985. The difference between the

# **FLOWCHART FOR ESTIMATING FUTURE SATURATION LEVELS FOR RANGES, DRYERS, FREEZERS, AND DISPOSALS**

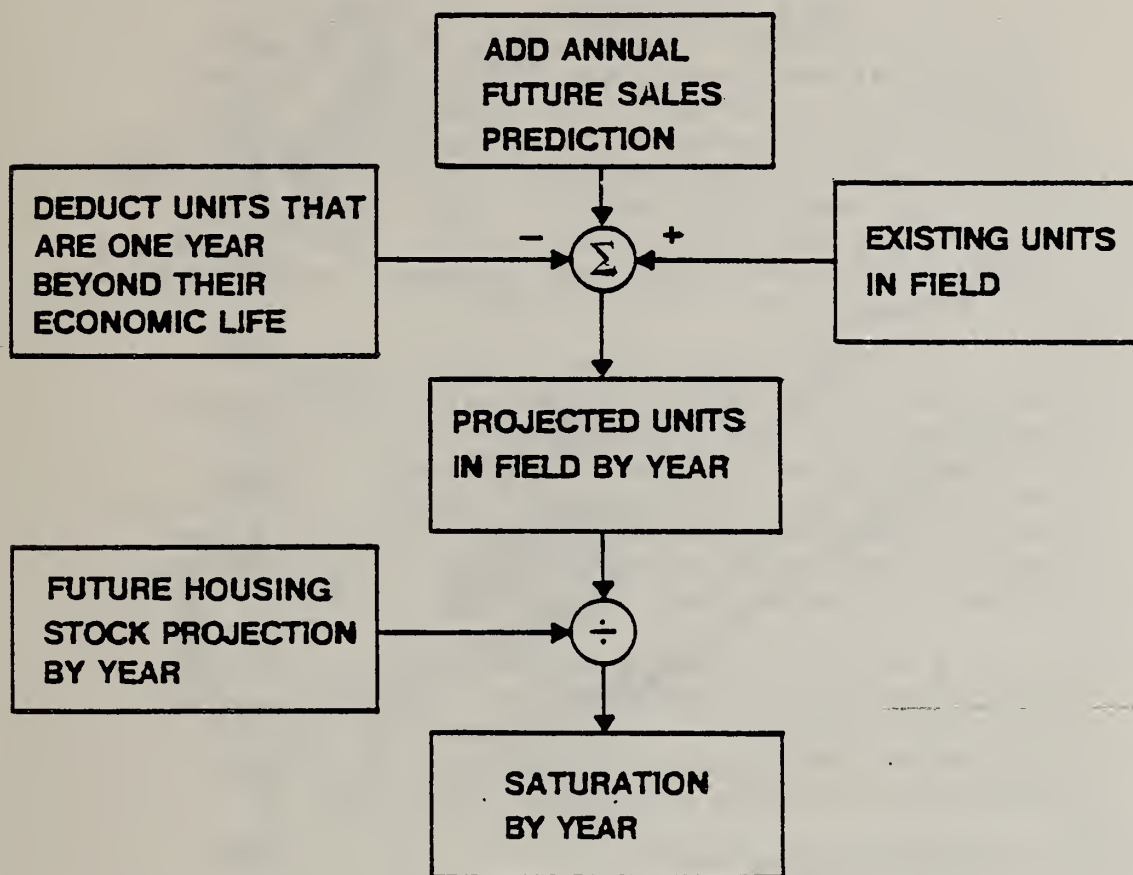
Figure 3.4

# FLOWCHART FOR ESTIMATING FUTURE SATURATION LEVELS FOR METHOD OF PROJECTION: DISHWASHERS, CLOTHES WASHERS, MICROWAVE OVENS

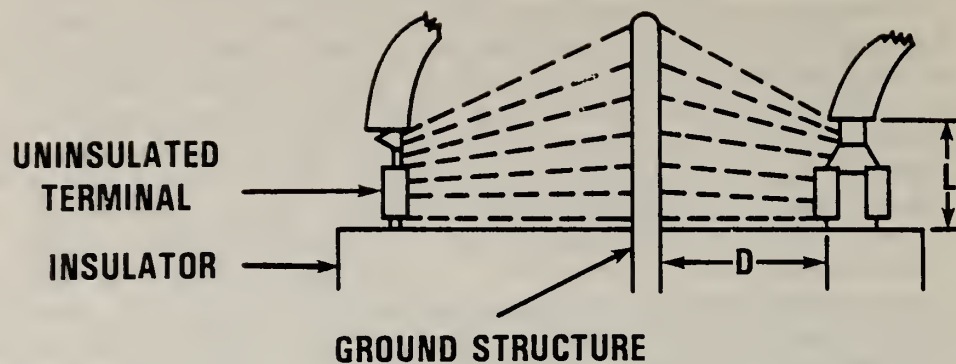
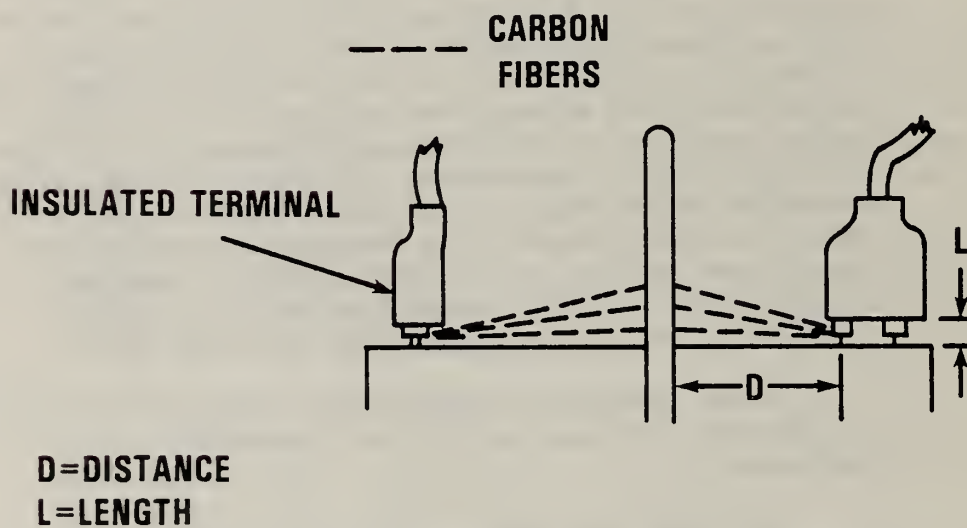
FIGURE 4.1  
LENGTH FACTOR HAZARD ANALYSIS

1. Exposed Surface. The likelihood of a carbon fiber connecting a node to ground is not only related to spacing but also to the contact surface exposed to fibers. Figure 4.1 illustrates this condition. From the figure it is obvious that there is greater potential for fiber connections with the uninsulated terminal than with the insulated one and that this difference is roughly proportional to the length and width of the exposed surface. Probability analysis can perhaps be used to quantify this factor so a measurement was taken of the other dimensional parameter-exposed conductive surface less than 20 mm away from a grounded surface for later use.

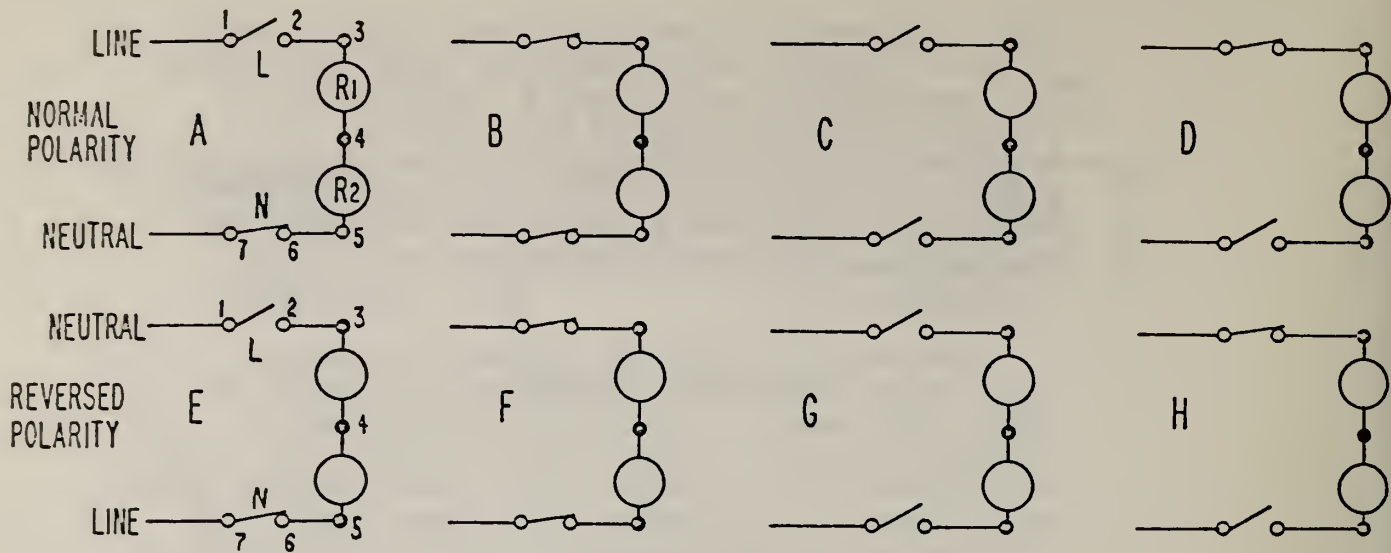
## Circuit Configurations

- Note:
1. Node numbers, loads, and switches same locations on all figure
  2. Loads energized only or circuits B and F
  3. R1 and R2 can be a single load
  4. Either or both switches may be used
  5. L = Switch is (normally) line side of incoming power
  6. N = Switch is (normally) neutral side of incoming power

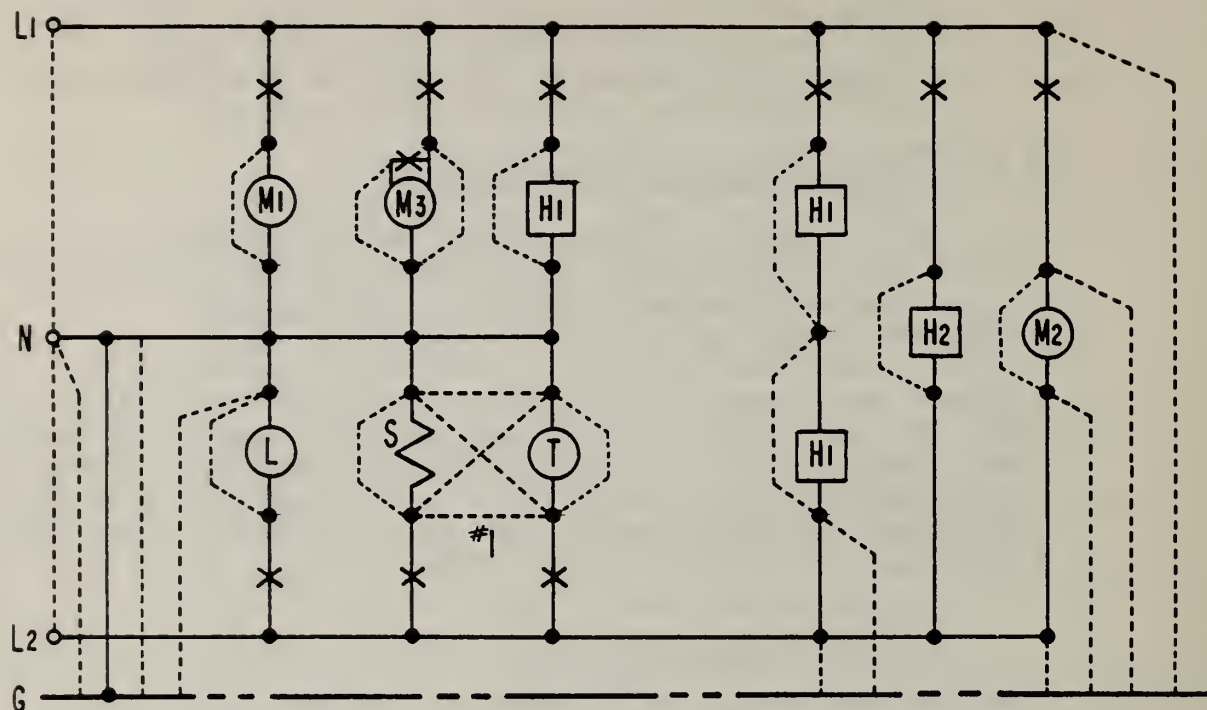
Figure 4.5 is a simplified circuit diagram of a power source applied to a number of operating devices. The X's on the figure

L1 = L2 = Power Input Terminals, 120/240 Volts  
 N = Power Input Neutral  
 G = Chassis Ground  
 M1 = Motor, 120V  
 M2 = Motor, 240V  
 M3 = Start Winding Type Motor  
 S = Solenoid  
 L = Lamp  
 H1 = Heater, 120V  
 H2 = Heater, 240V  
 T = Clock Motor

----- = Carbon Fiber  
 \_\_\_\_\_ = Conductor  
 X = Control Switch  
 O = Terminal or Node  
 --- -- =

The exception to the above that should be considered is circuits where two devices are in series. The two heaters across 240 volts shown in Figure 4.5 indicate two identical units which, when in series, would have 120 volts across each. These of course behave identically to other 120 volt devices as far as carbon fibers are concerned.

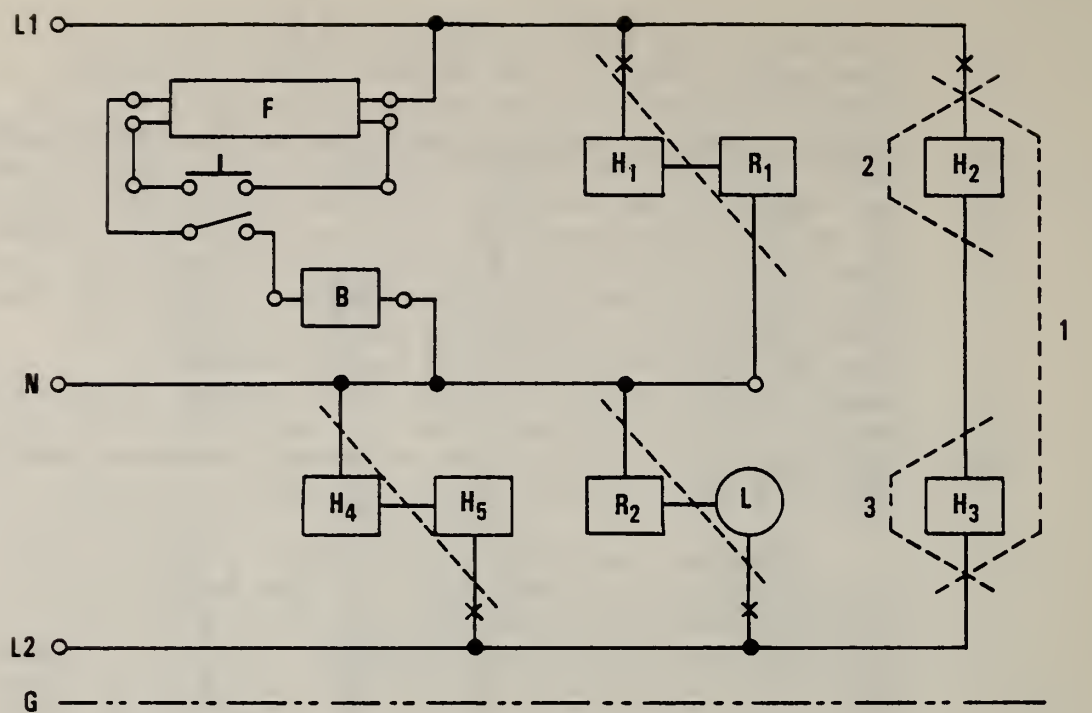
Figure 4.6A shows several configurations of output devices in series that are not pairs of

L1, N, L2, G=INPUT POWER CONNECTIONS 240/120 VOLT

F=FLOURESCENT LAMP

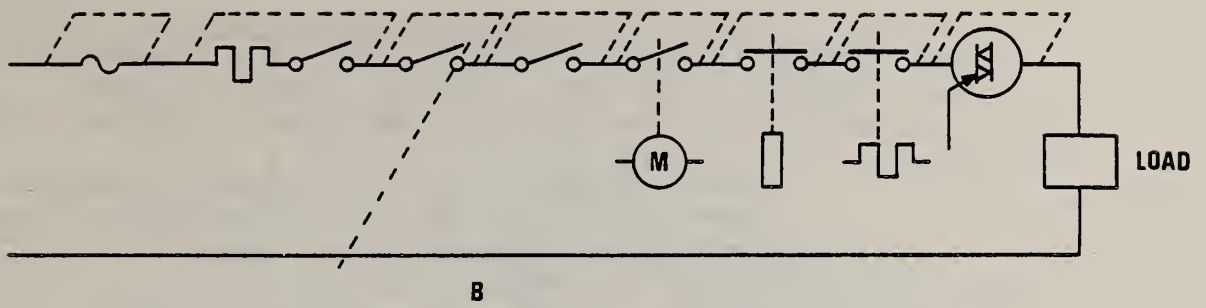
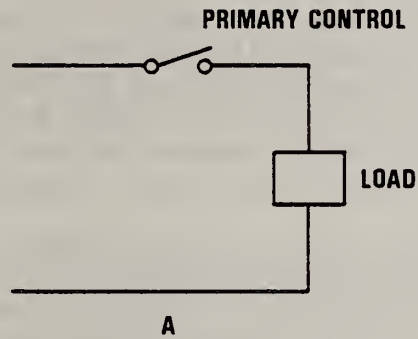
Figure 4.7A illustrates the basic circuit of all primary controls. Figure 4.7B shows a series chain that includes one of each type of primary control; any one of which, when opened, will interrupt current to the load. The dotted lines around the devices indicate possible carbon fiber paths. It can be seen that if the control device is conducting (closed) a fiber will have no effect. Except for very low-wattage loads, if the device is open, the fiber will burn out unless another control in the series chain is open. In this case, the fiber will have no effect until all other switches are closed which will then cause the fiber to burn out. One of the many possible fibers is shown drawn from a control device terminal to the line on the opposite side of the load. All such fibers will have no effect when the switch is open but will burn out when the switch (or switches) closes. Again, there would be no effect on load operation. Further consideration shows that it makes no difference whether the primary control device is in the line or neutral conductor nor will voltage effect operation. Should the fiber not burn out, its resistance would prevent enough current from flowing to cause the controlled load device to operate. The only exception to the above would be if the output (load) controlled consumes less than ten or so watts at normal voltage. Such light loads are more likely to be incorporated in electronic products than in appliances (pilot indicator lights will be discussed later). Any such low-wattage output devices must be considered separately for fault effects.

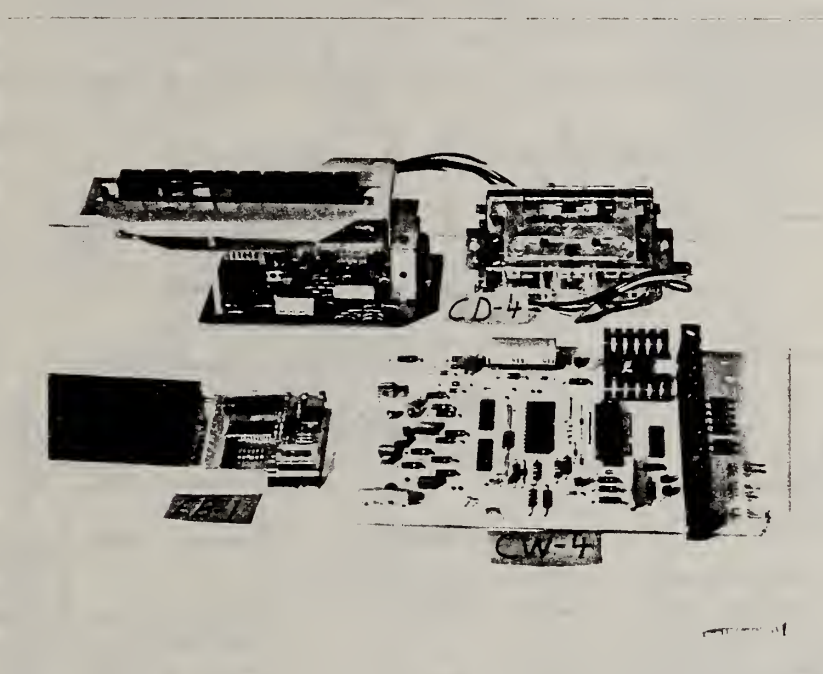
Figure 4.9

The clothes dryer was disassembled and a standard analysis was made of all parts other than the electronic circuit. The electronic circuit is self-contained, see picture Figure 4.9, and consists of a single-sided printed circuit board, approximately 10 x 15 cm, with three multiconductor terminals, a power supply transformer and the electronic components mounted on it. Separately attached to the board is a 10-pushbutton switch assembly with its own printed circuit board and connector. A wiring harness interconnects the two boards and a second harness connects the main board to a relay assembly having three relays in one assembly. One of these relays can only be closed by manually depressing its armature with the "on-off" switch button. Once depressed, the closed relay contacts apply line power to the dryer and its electronic circuit which in turn supplies current to the relay coil to hold it closed. At the same time, current is supplied by the electronic circuit to the other two relays to close them (magnetically). One of the relay's contacts supplies 120 volts to the motor that turns the dryer drum. The other relay supplies 240 volts to the heater. The heater however cannot be energized unless the motor is running since a centrifugal motor switch is in series with the heater. The heater can also be turned off by a separate (nonelectronic) temperature control thermostat switch or by a safety temperature limit thermostat.

Clothes Dryer Electronic Control  
CD4 (at top)

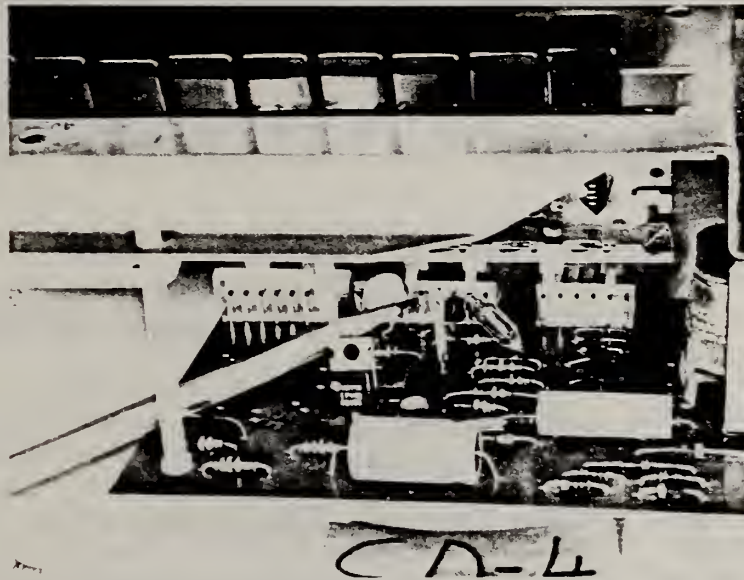
Figure 4.12

Observation of the circuit board shows 14 possible fiber connections from TP1 to other nodes. In Figure 4.12; the pencil points to TP1. One of these 14 possibilities, a connection to TP2, would be a nonhazardous burnout or nonhazardous load. Three would be directly to ground and potentially hazardous. Five connections could connect to ground through the

Clothes Dryer - Pencil at TP1

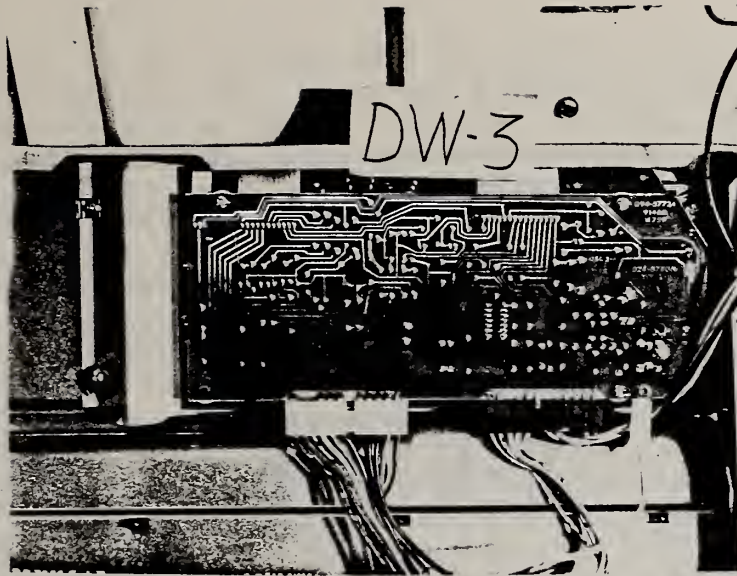
Figure 4.16

DISHWASHER  
ELECTRONIC  
CONTROL

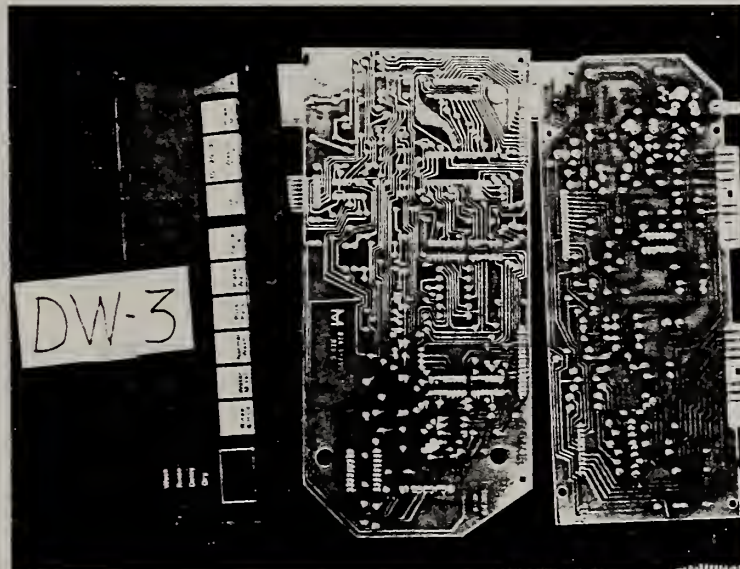
Figure 4.17

Installed in  
Dishwasher

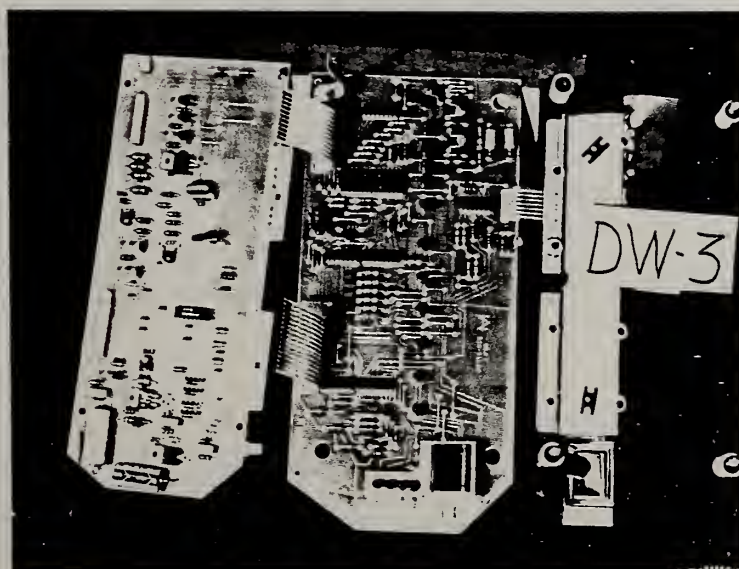
Figure 4.18

Soldered  
Sides

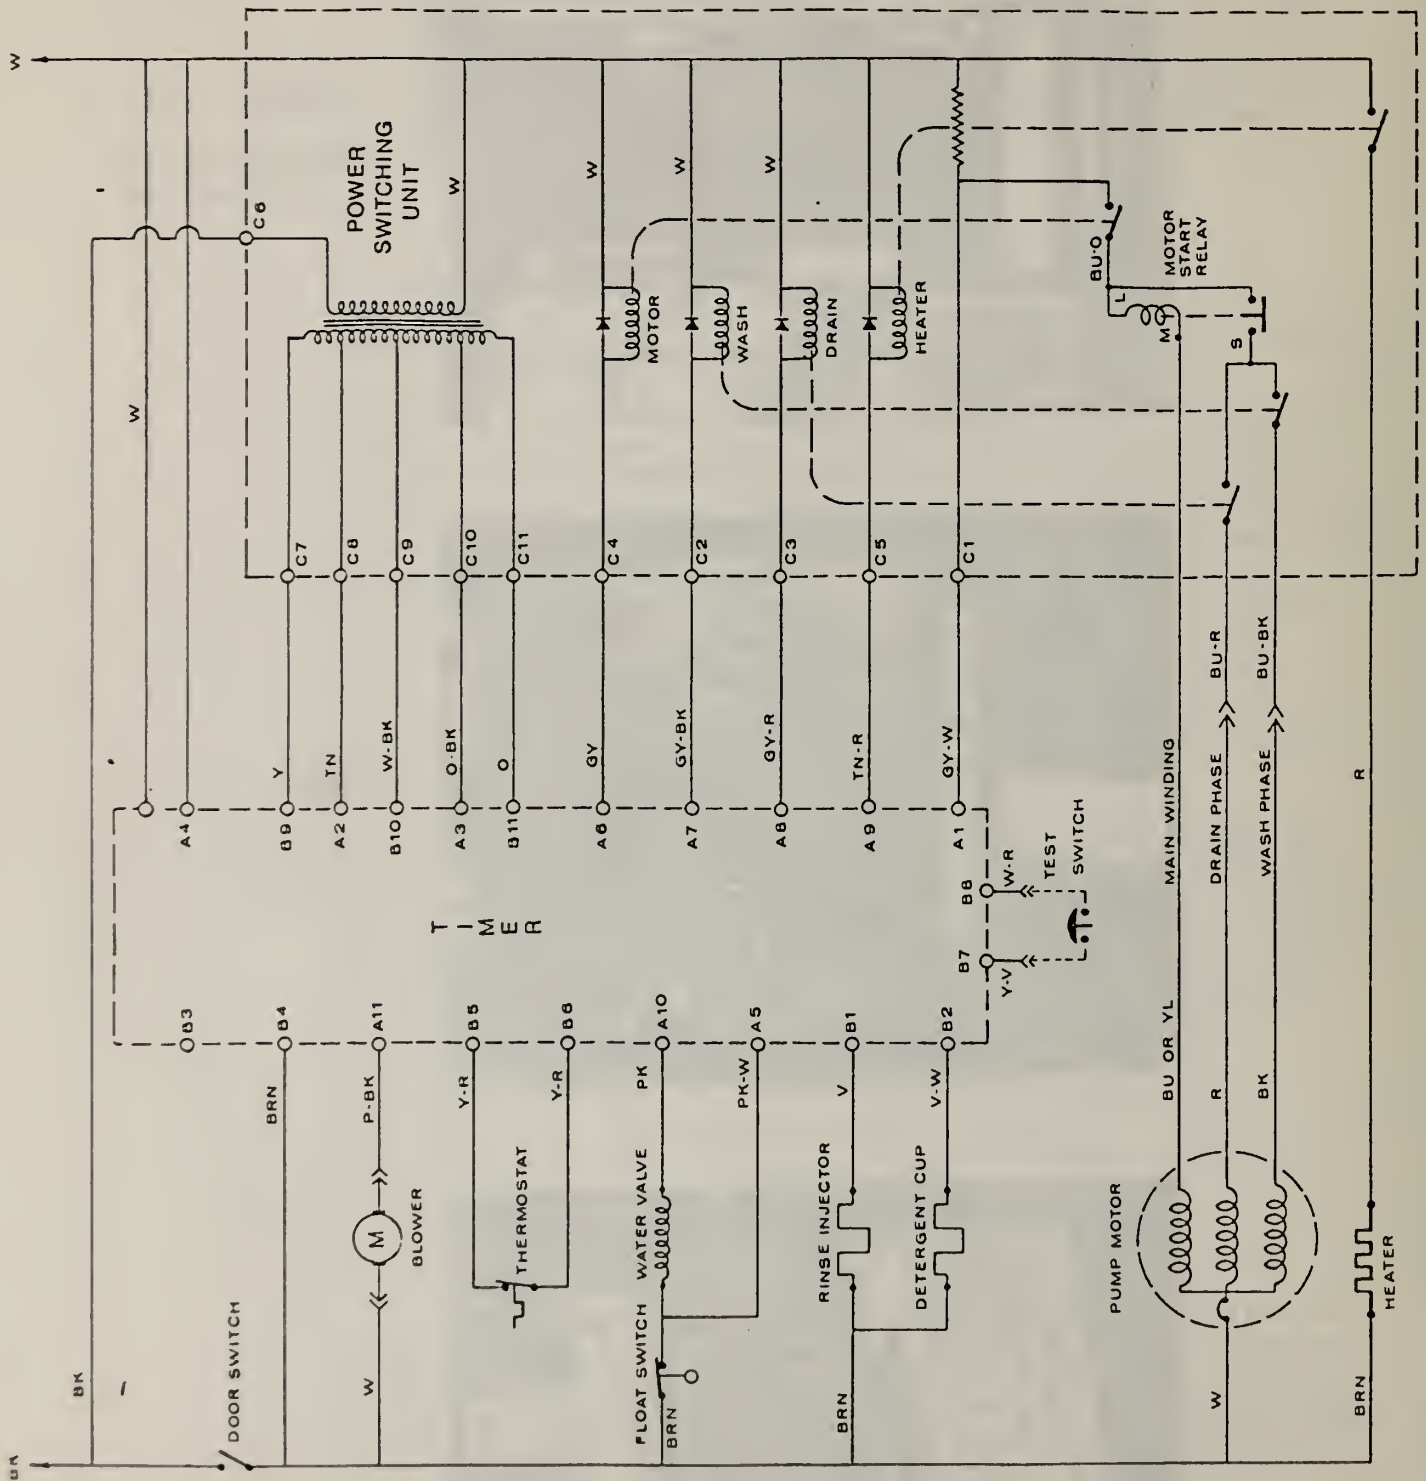
Figure 4.19

board in the range is a large one, about 12 x 58 cm. See Figure 4.20. On this board are mounted all of the electronic circuits, displays, spring contacts to the finger sensing pads, and transformer. A schematic diagram of some of the electronic circuits was drawn and is shown in Figure 4.21. Figure 4.22 is a copy of the power circuits supplied with the range. The transformer on the circuit board has a high voltage winding needed for the displays as well as a low voltage isolated winding to supply the logic circuits. This low voltage is connected to the neutral line through a voltage regulating power transistor. Because of the use of a stepup transformer, many of the circuits on the electronic printed circuit board must be considered potentially hazardous as related to carbon fiber connections less than 20 mm to structural conductive parts. The product is a Type II device and as such the likelihood of a floating chassis (ground connection removed) is minimal. Also, the circuits connected to the neutral incoming power connector (N) cannot be made hazardous. This is so because the range would be otherwise inoperative if either of the line voltage power connectors were inadvertently connected to the neutral terminal. A limited measurement of node to ground distances showed more than 20 locations on the board that were less than 20 mm from ground and thus might constitute a hazardous condition. As with the other electronic products, the fault possibilities are too numerous to itemize or analyze. Mechanical interlocks and an overlimit thermostat provide adequate protection from hazardous oven temperatures. A hot surface warning pilot light provides protection from unsuspected hot surface units should the electronic circuits cause them to turn on unexpectedly. The possibility does exist that combustible items could be left on an unattended surface unit at the time that a fiber causes the heater to go on. This is a potential hazard but such a hazard would also exist with nonelectronic type ranges since carbon fibers are not the only way the hazards could develop. This electronically controlled model range has been reported to be no longer manufactured.

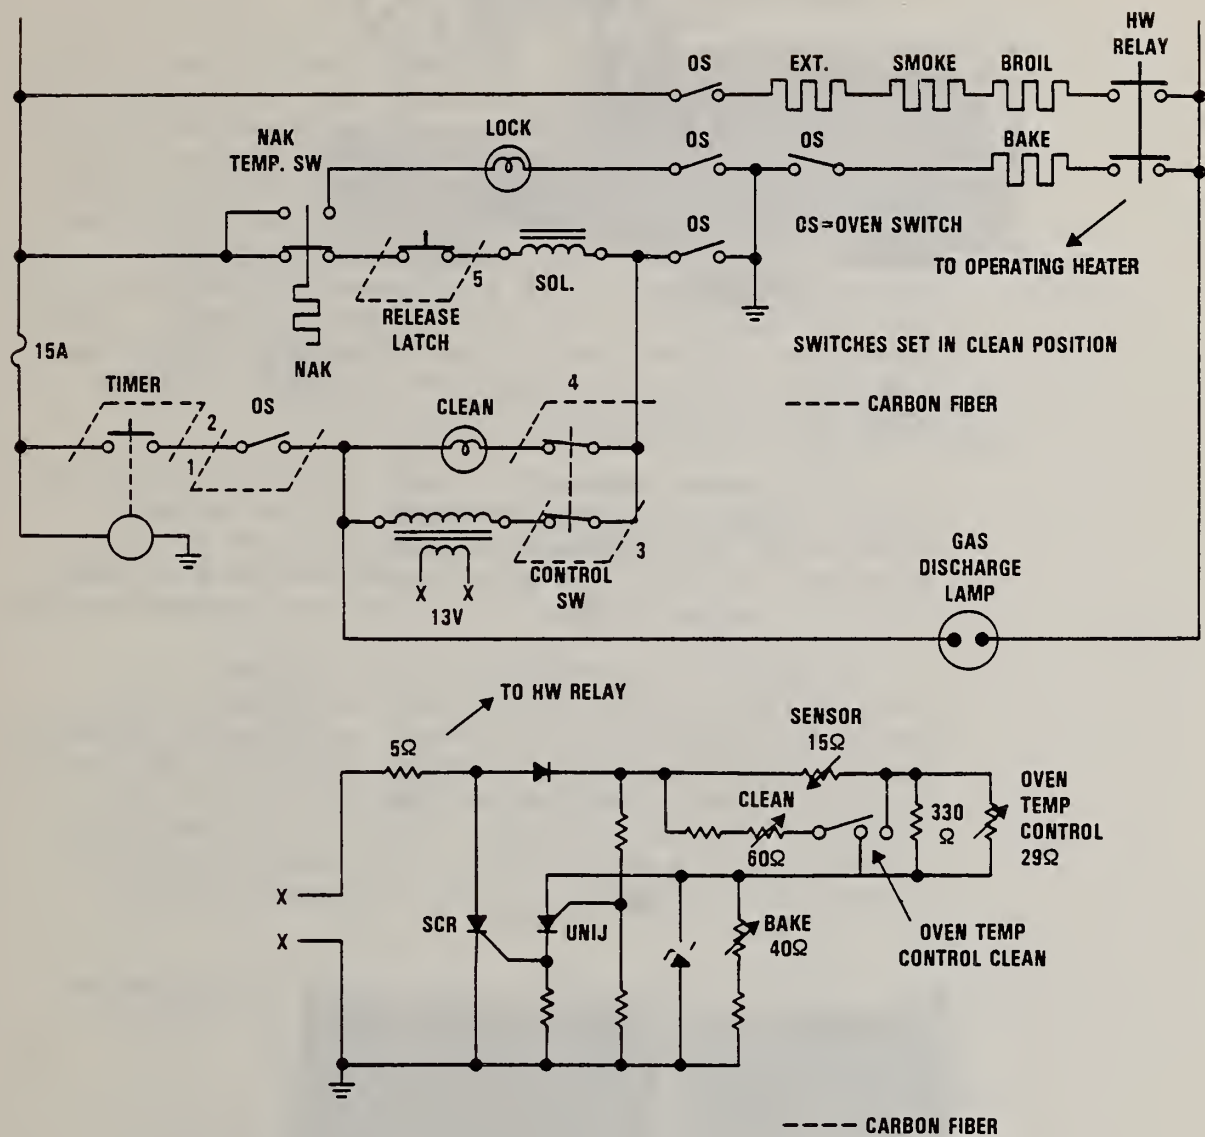
FIGURE 4.24  
SELF CLEANING RANGE

Electronic Control Left  
Cleaning Range

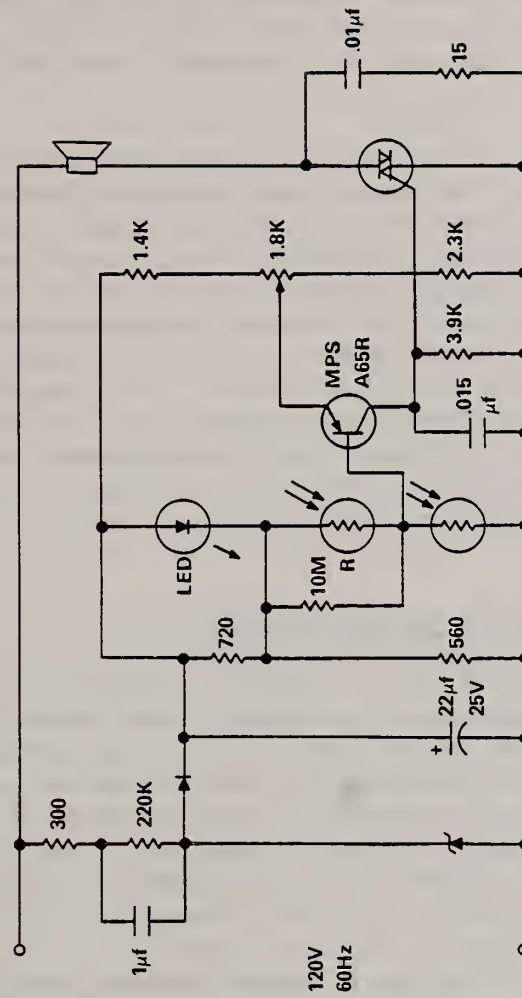
Figure 4.29

# PHOTOELECTRIC SMOKE DETECTOR SCHEMATIC CIRCUIT
